Above the Flood: Elevating Your Floodprone House

FEMA 347/ May 2000

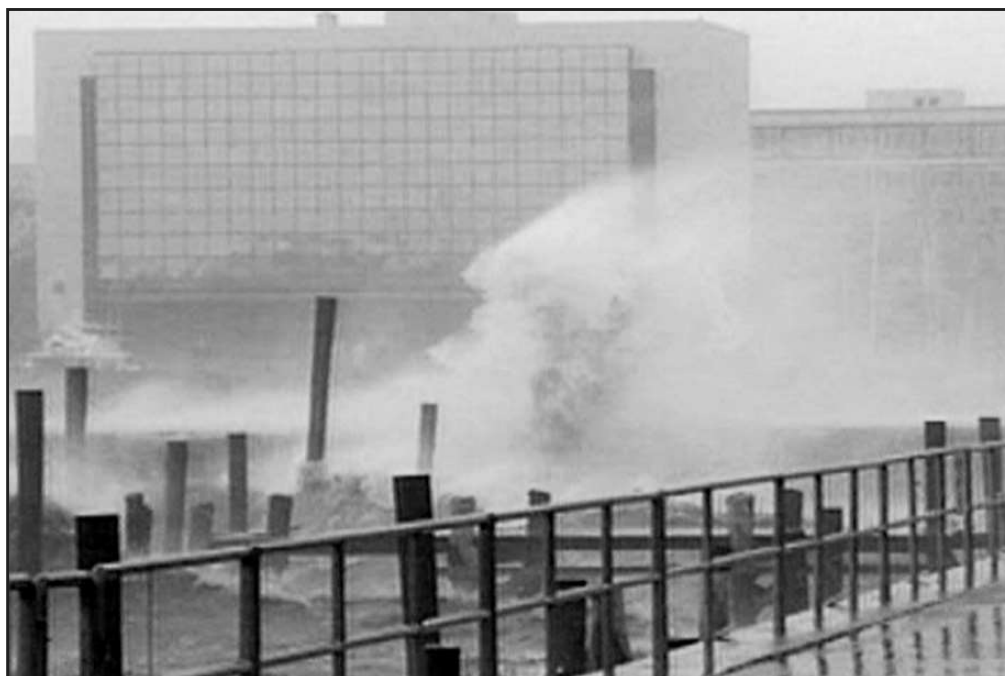
Figure 2
Damage to houses
and other buildings
was severe.

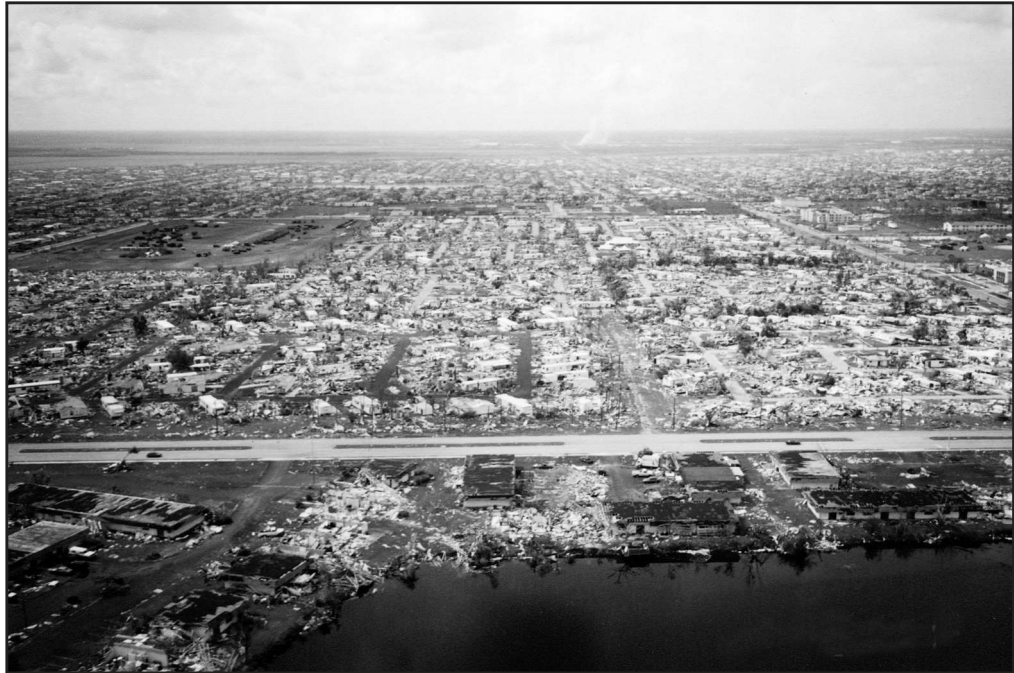
Figure 3
Wind damage.

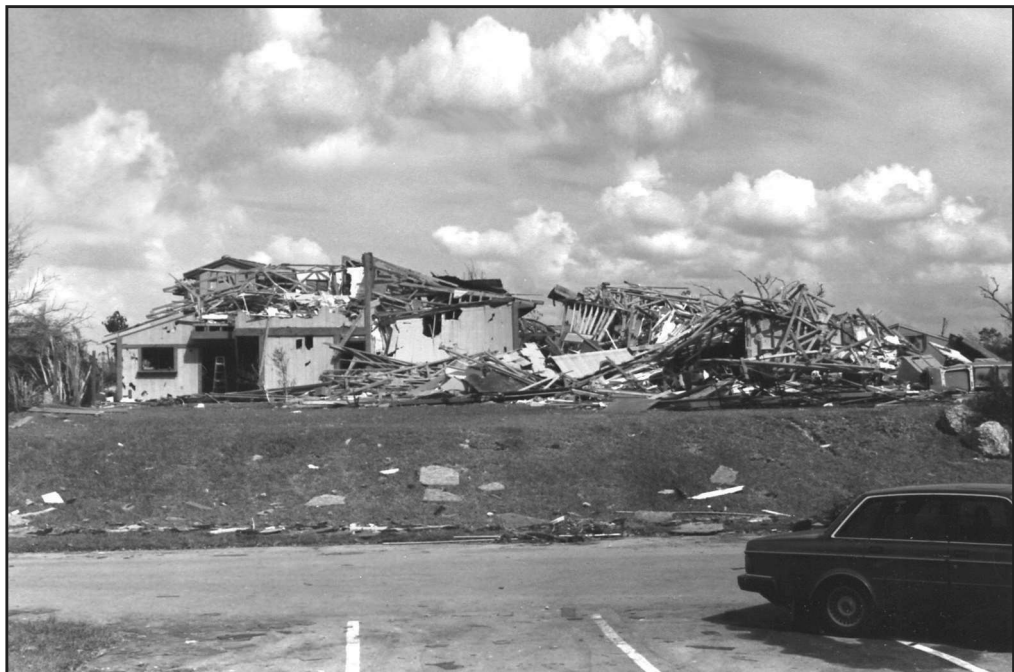
Figure 4
In low-lying areas, wind and rain damage to interior finishes and furnishings was exacerbated by flood waters.

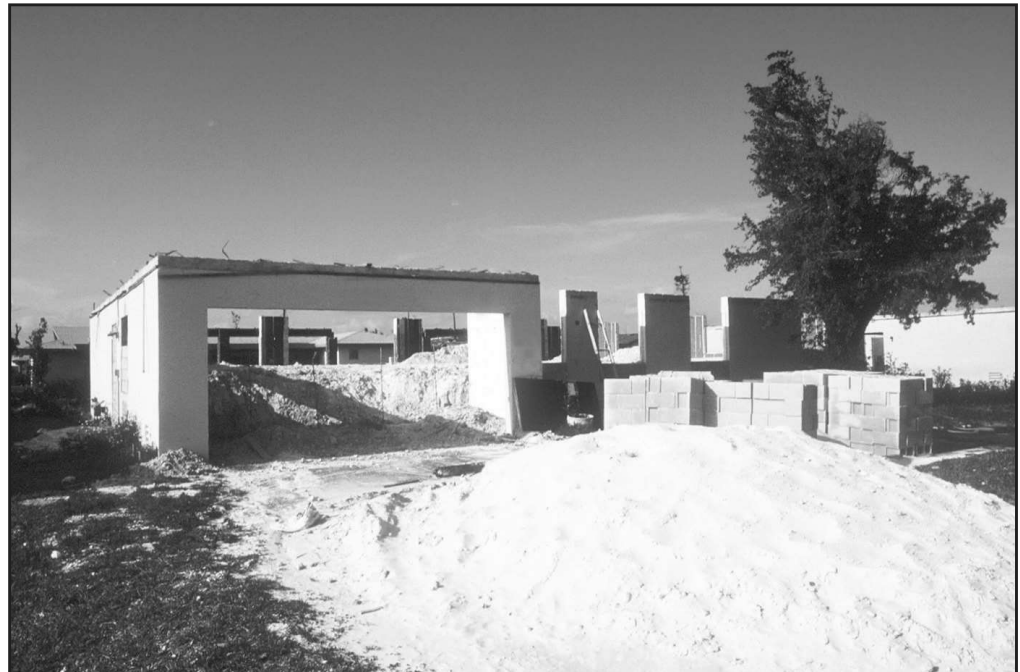
Figure 22

The first case study house (Figures 22–32) has masonry walls and a slab-on-grade foundation. The roof of this house was severely damaged by high winds during Hurricane Andrew, and the interior walls suffered extensive damage from flood waters and rain. The owner decided to raise the lowest floor above the BFE by extending the walls upward, placing sand fill on top of the original slab floor, and pouring a new, elevated concrete slab on top.

The front of the house at the beginning of the project. The interior walls and contents, which were destroyed or severely damaged by flood waters, wind, and rain, have been removed. Sand has been placed on top of the old slab to provide the base for the elevated lowest floor. The concrete blocks that will be used to extend the walls can be seen stored in the foreground.

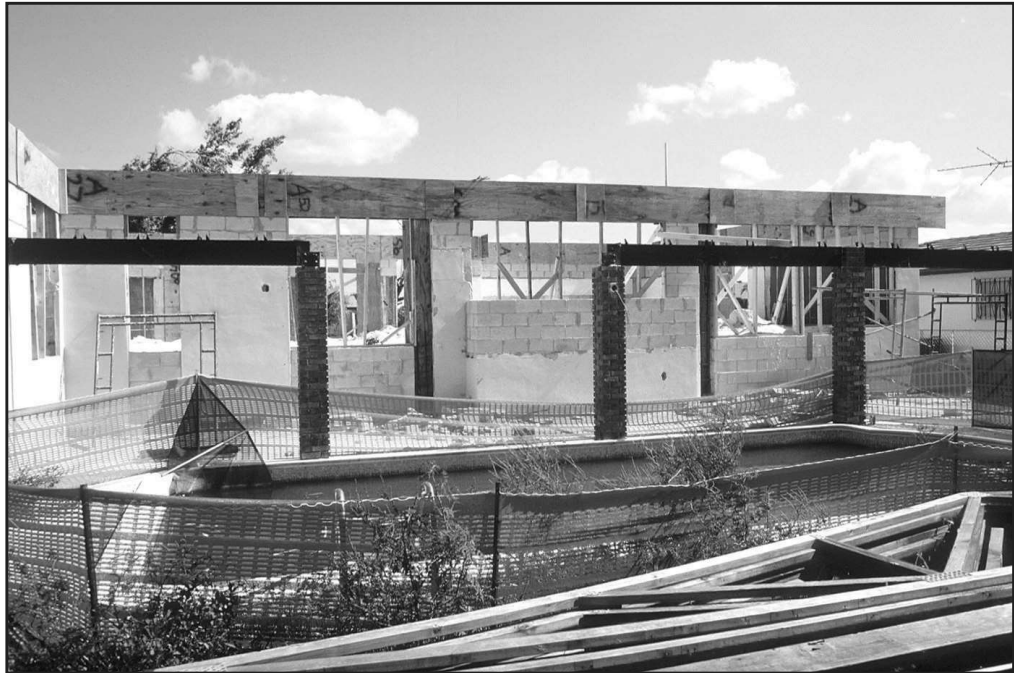
Figure 23
View from the back of the house. The walls have been extended upward with concrete blocks. The plywood visible at the tops of the walls is used to form cast-in-place concrete bond beams that will strengthen the extended walls. The roof trusses shown in the foreground were salvaged for reinstallation. The owner of this house decided to replace the original roof sheathing and shingles with new materials.

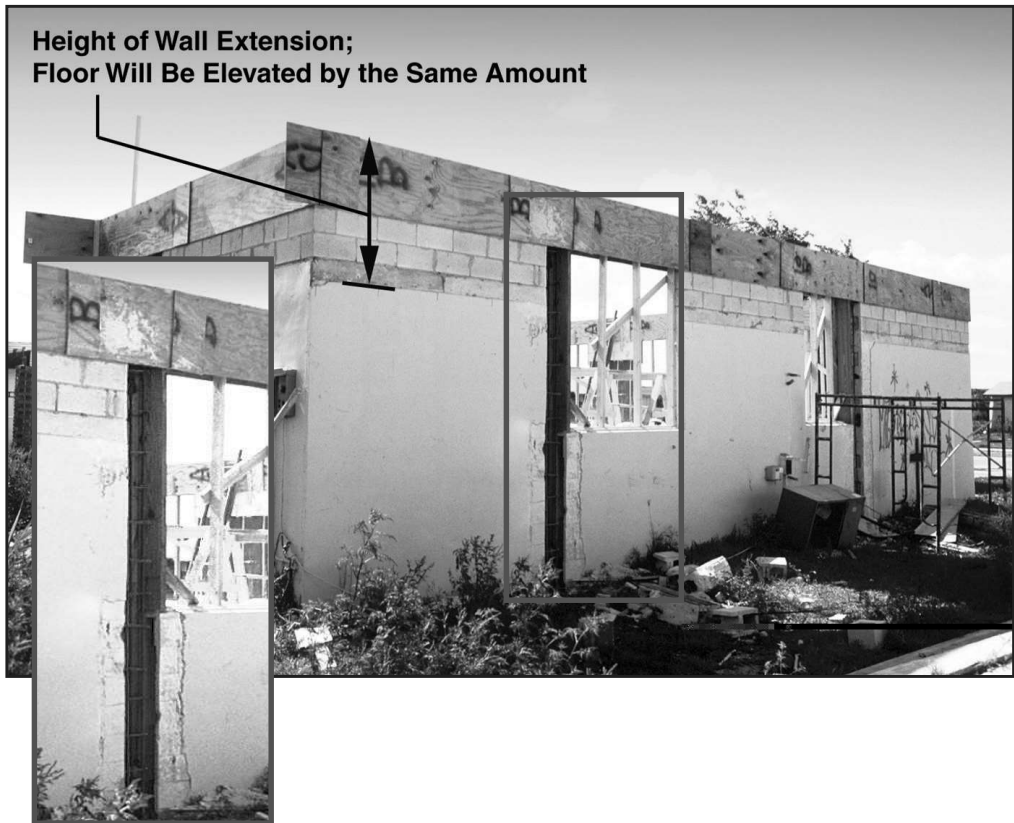
Figure 24
Another view of the extended walls. The vertical cuts in the walls next to the windows are for concrete tiedown columns that will be cast in place to further strengthen the extended walls against wind loads. The owner of this house was able to meet the elevation requirement by raising the floor only a few feet, as indicated by the amount that the walls have been extended.

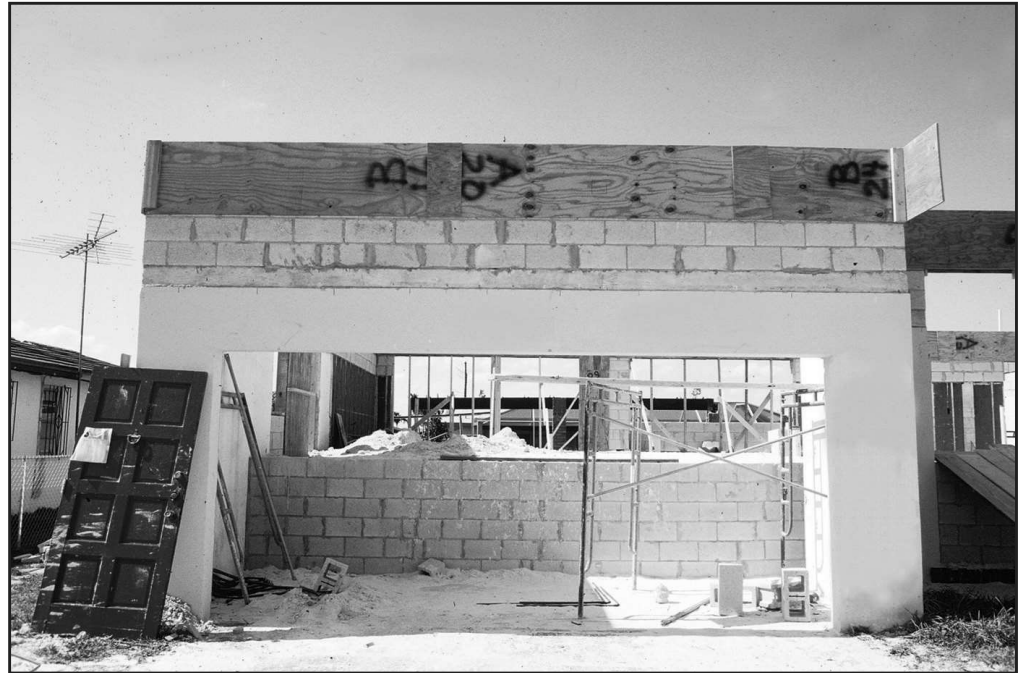
Figure 25

This view through the garage door reveals the different levels of the elevated slab floor, in the background, and the unelevated garage floor.

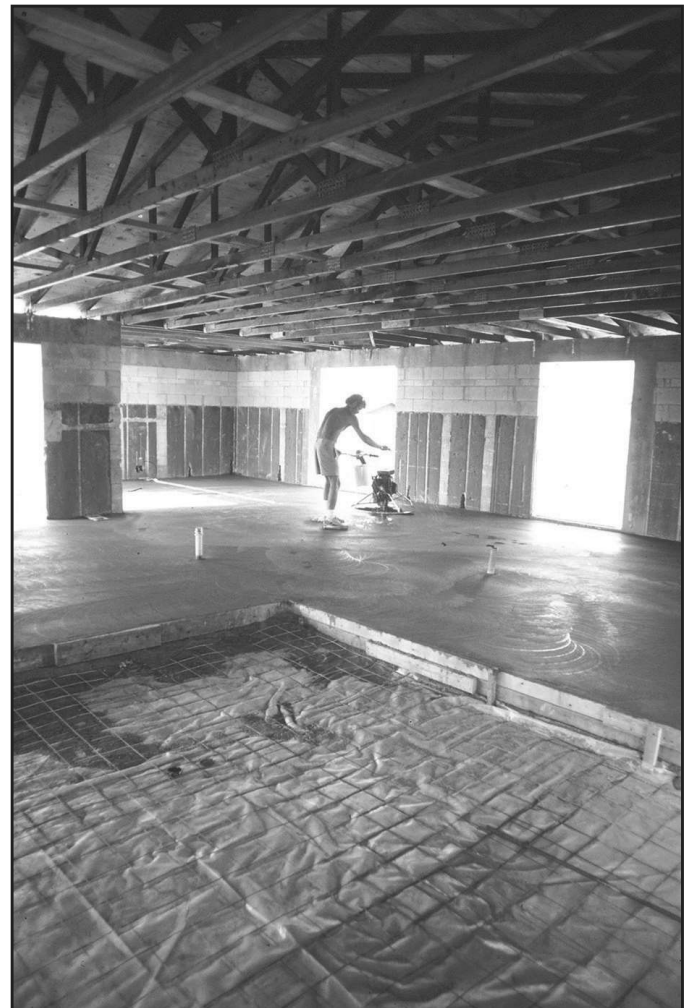
**Figure 26**

The roof has been rebuilt with the salvaged trusses, and most of the new concrete slab has been poured on top of the sand fill. The open area in the foreground, where plastic sheeting and wire reinforcement can be seen on top of the sand fill, is where the remaining part of the slab will be poured.

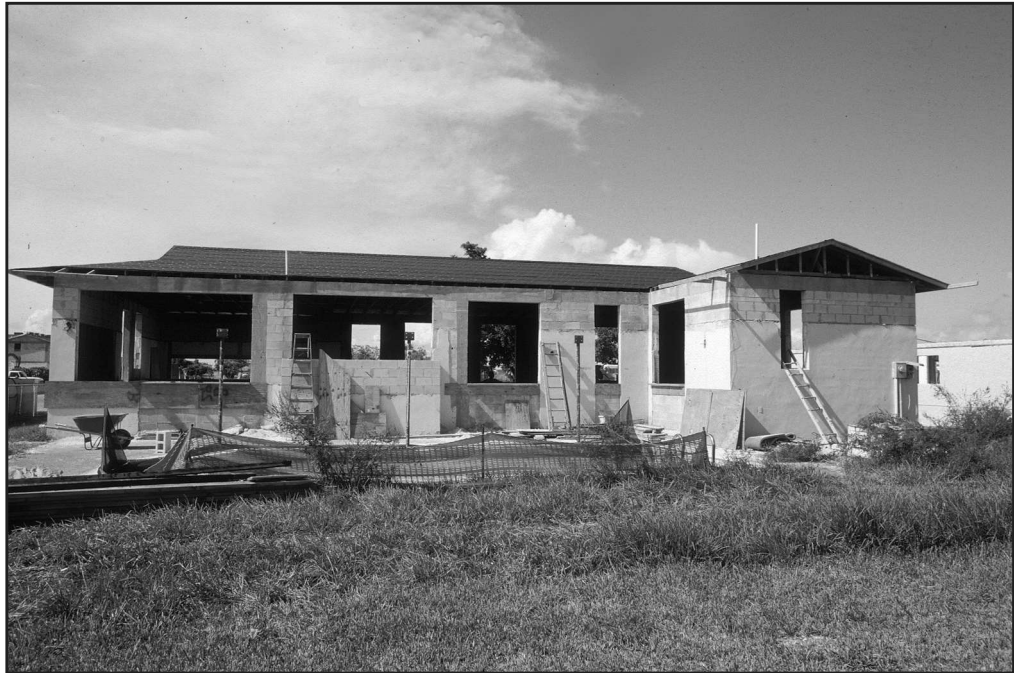
Figure 27
As work progresses,
the elevated house
begins to take shape.

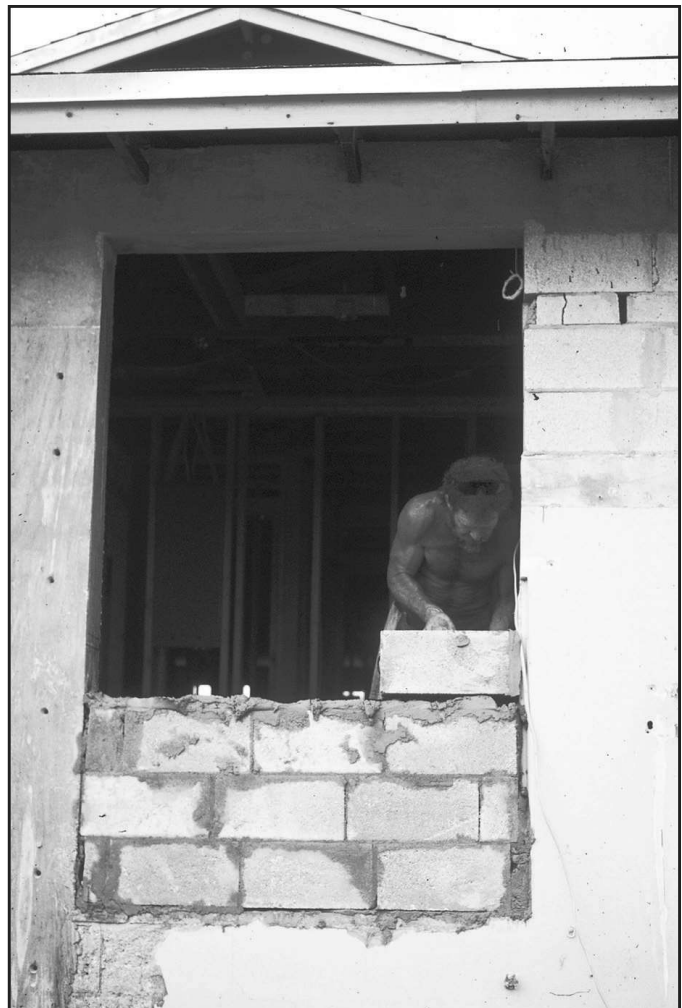
Figure 28
The bottoms of the
original window
openings are raised
with concrete blocks.
